Aerial Remote Sensing of Ground-Water Contamination Sources

Eastern
San Fernando
Valley: 1937-1964

December 1986

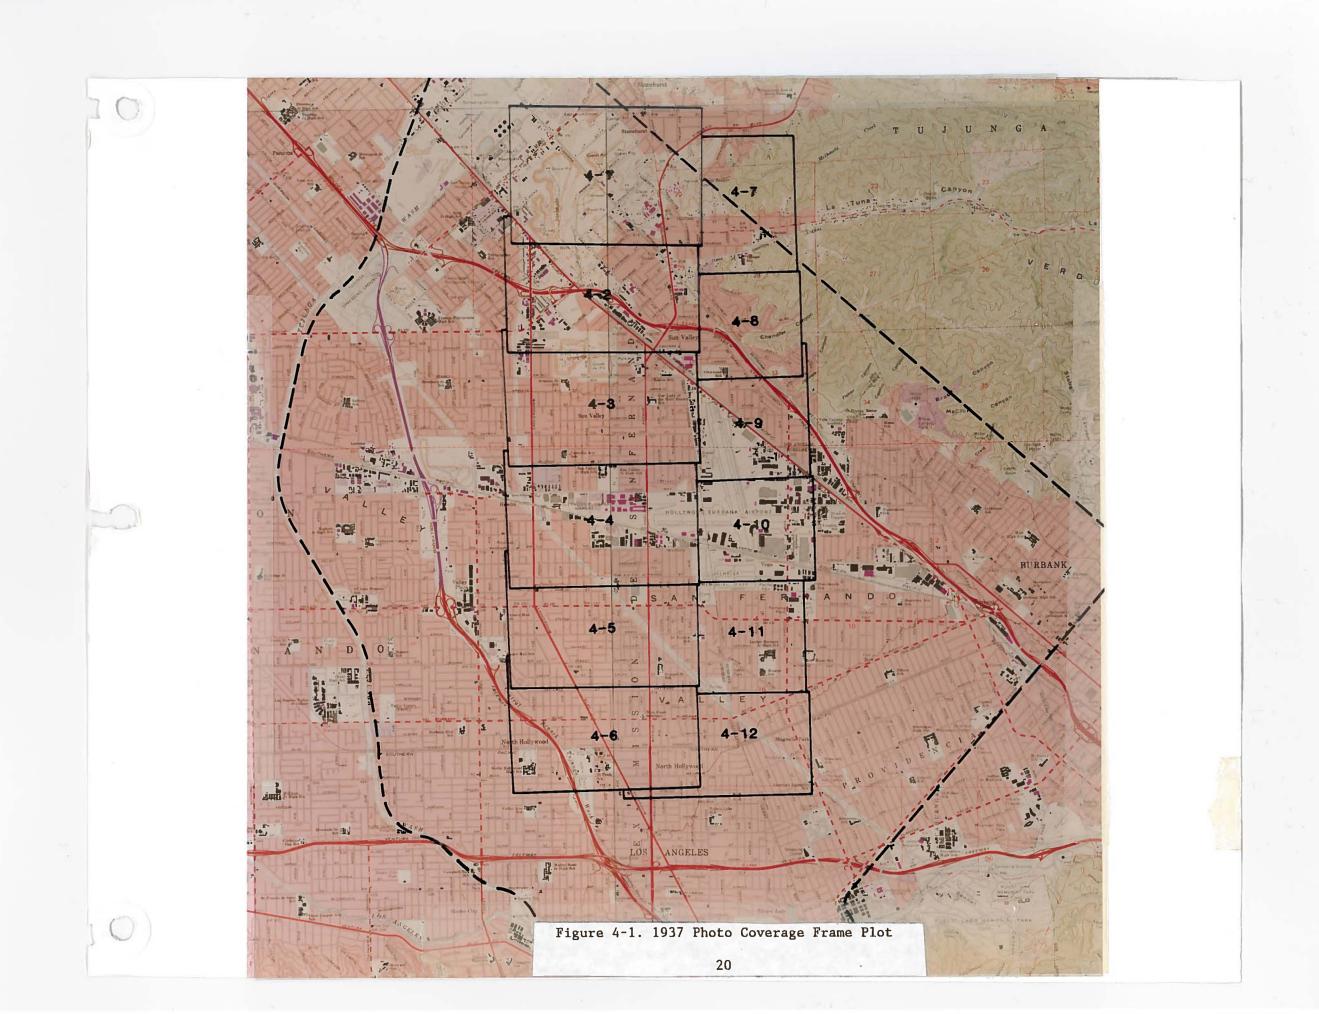
Photo- graph Number	Administrative Area	Major Cross Streets	Potential Contamination Source	Description/Comment
4-8	Los Angeles	Strathern-San Fernando	ol-Fuel Distribution Facility	1 - Two uncontained vertical tanks are present.
4-9	Los Angeles	Clybourn-San Fernando	Tanks (2)	1 - Tanks are associated with a gas station.
	Burbank	Clybourn-Cohasset	2-Mounded Material	2 - Material appears to be sand/gravel stockpiles.
		Clybourn-Cohasset	3-Gravel Pit	3 - Pit is clean.
4-10	Burbank	Clybourn-Empire	1-Mounded Materials	1 - Materials are located behind unidentified commercial facility; appear to be combination of solid waste and clean fill.
		Empire-Hollywood Way	2-Pit	2 - Pit appears to be on Burbank-Union Airport property.
4-11	Los Angeles/ Burbank	-	None Observed	-
4-12	Los Angeles	Hatteras-Clybourn	1-Trench	1 - Feature recently excavated, no visible waste disposal.
